HOUSE RELOCATION TO:

11 FREDERICK ST, BIGGENDEN

Existing Dwelling Relocation Report

STANDARD TIMBER PEST REPORT

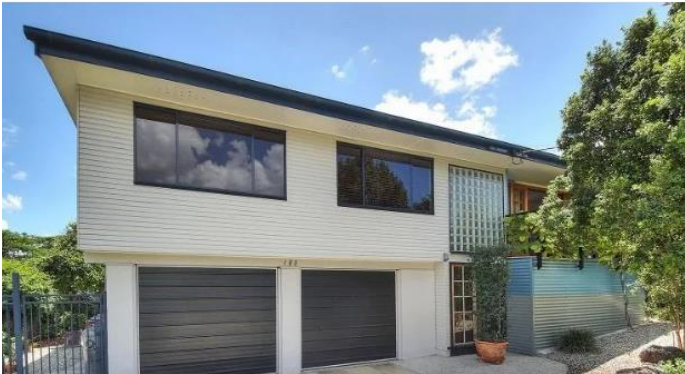
Site Photo 1 - Front

The first floor framing and roof framing was observed to be in generally good condition given the age of the building. Although no analysis was conducted on the floor framing to check against current design standards, the structure did appear to be robust.

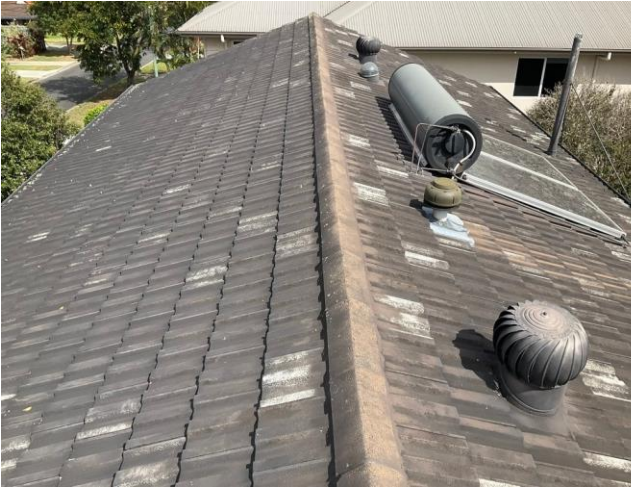
Photo no: 1. Section C, roof exterior inspected.

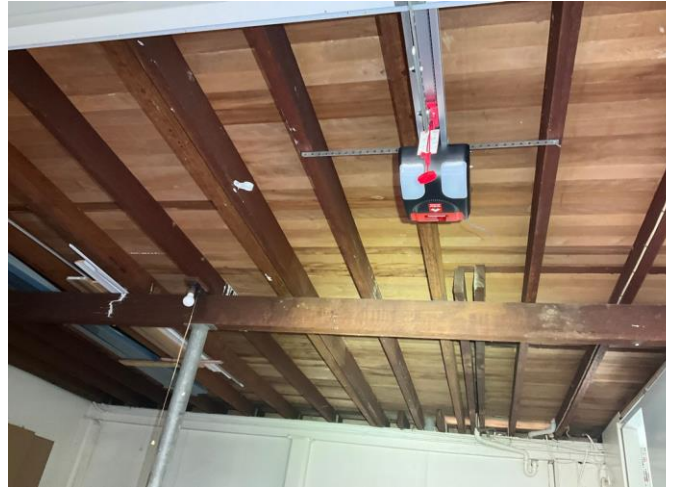
Photo no: 2. Section C, subfloor framing where visible.

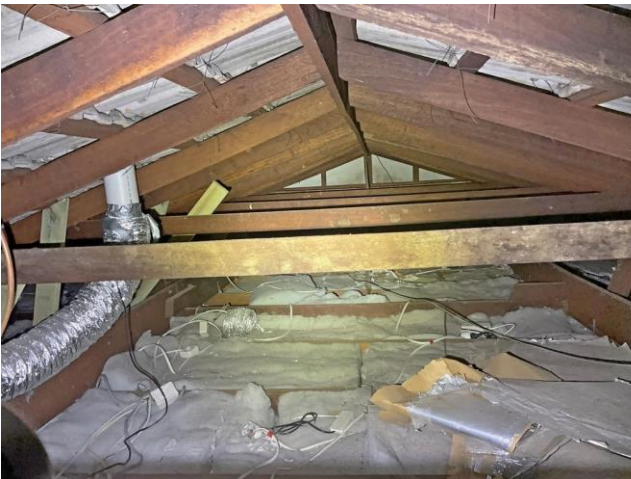
Photo no: 3. Section C, roof space inspected.

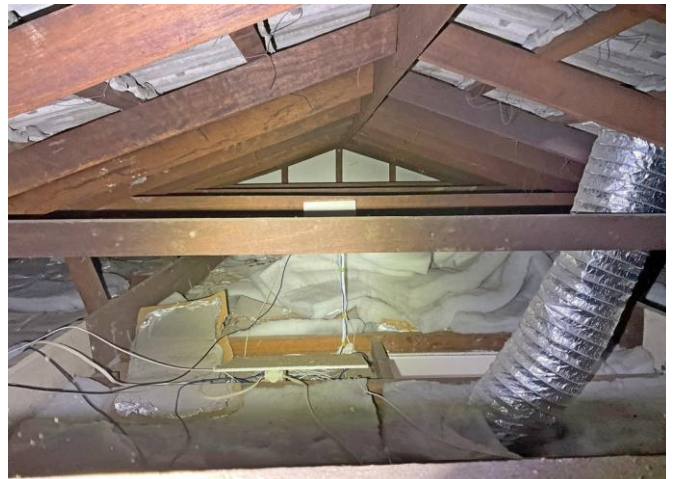
Photo no: 4. Section C, roof space inspected.
