ROAD SAFETY AUDIT

DETAILED DESIGN STAGE

Wetheron Road, Wetheron

Bon Accord Bridge Upgrade and Approach Works

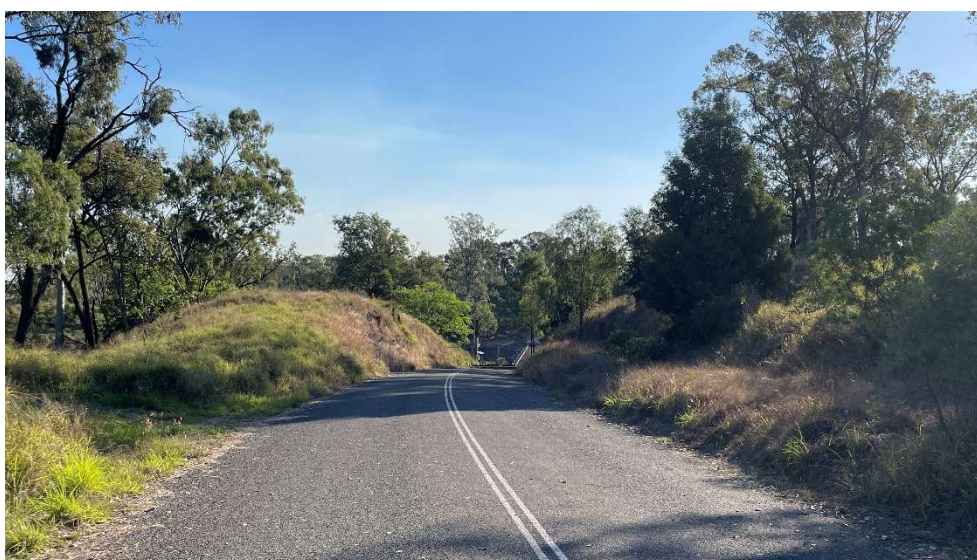
Figure 3: Eastern Approach to the Bon Accord Bridge (Continuous Side)

The combination of horizontal and vertical alignment approaching Barambah Creek (Bon Accord Bridge) from both east and west severely restricts sight distance, giving motorists little forward awareness of the tight vertical alignment, narrowing cross section and vision to oncoming vehicles. Motorists also cannot identify if water is flowing over the road.

It is important that adequate approach sight distance be provided to allow motorists time to recognise the change in road conditions, oncoming vehicles or water over the road, and slow down, react and stop if necessary.

Poor sight distance increases the risk of loss of control, run off road and head on crashes at this location.

Risk Ranking Decision Process: Frequency: Unlikely, Severity: Serious, Risk: High.

- Check stopping sight distance parameters to ensure that sufficient sight distance is available for the following conditions:
 - o To oncoming vehicles crossing the bridge.
 - o To floodwater overtopping the roadway at maximum likely flood height.
- Improve available visibility by excavating the existing cuttings on the inside of both approaches to the bridge.

If sufficient sight distance is not achieved, consider:

- Installing reduce speed signs (G9-9).
- Installation of VAS "slow down" signage on the western approach.
- Undertaking a speed review and implement a regulatory reduced speed limit over the bridge and approaches.

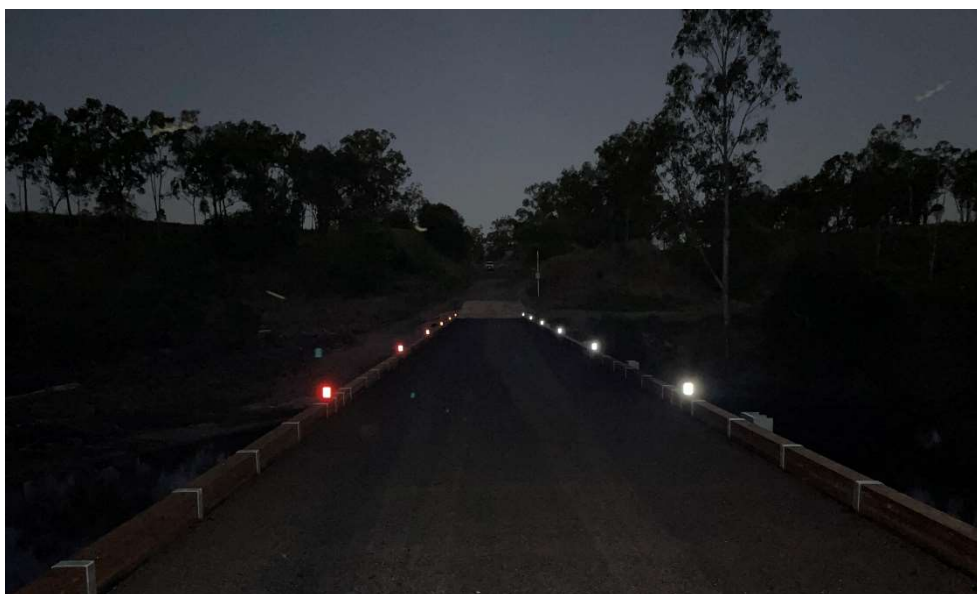
Figure 5: Delineation on bridge at 16 September 2024

The design drawings do not indicate the installation of guideposts as part of the project. The approaches to the bridge has insufficient guideposts to delineate the edge of the roadway to help guide motorists, especially at night. Poor delineation increases the risk of motorist failing to identify the road geometry and increasing the risk of loss of control, run off road and head on type crashes.

Risk Ranking Decision Process: *Frequency: Unlikely, Severity: Serious, Risk: High.*

- Consider the installation of guidepost on the approach curves to the bridge in accordance with AS 1742.2:2022 MUTCD Part 2.
- Consider reduced spacing of guideposts due to known fogs in the area.
- Consider the installation of RRPM's on linemarking on the bridge to improve nighttime delineation of the roadway.

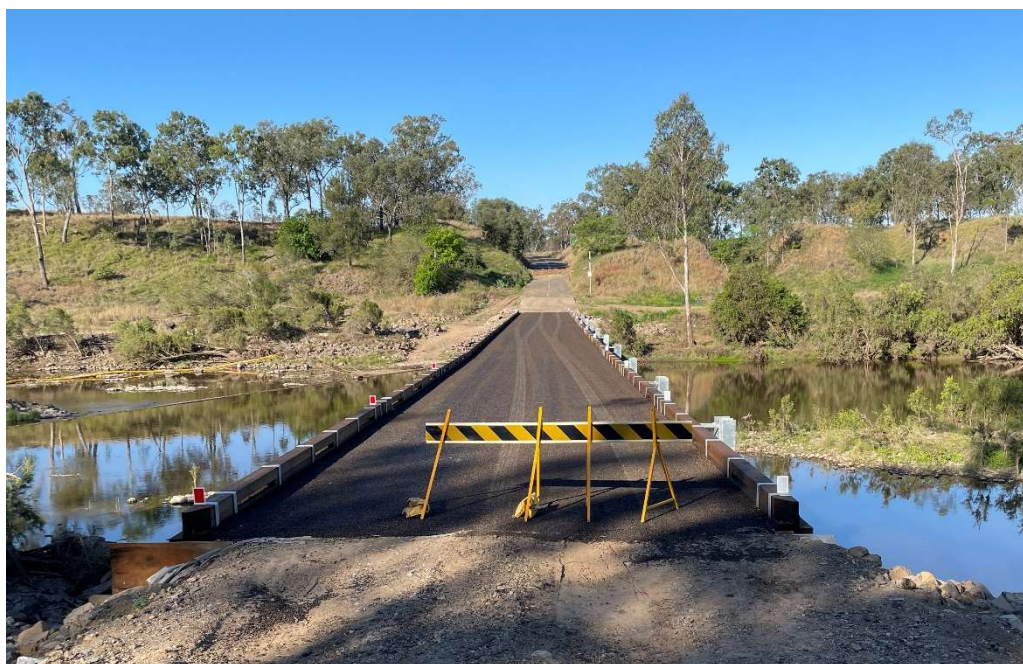
Figure 6: Existing Bridge No Linemarking

The design drawings do not indicate if edge lines are to be painted across the bridge. AS 1742.2:2022 MUTCD Part 2 indicates that edge lines shall be provided for one-way bridges that are greater than 60m in length. The exclusion of linemarking increases the risk of motorists failing to drive in the middle of the bridge, striking the bridge kerbs and motorists thinking it is still a two-way bridge.

Risk Ranking Decision Process: Frequency: Unlikely, Severity: Serious, Risk: High.

- Consider the installation of edge lines across the bridge in accordance with AS 1742.2:2022 MUTCD Part 2.
- Consider the installation of RRPM's on linemarking approaching and on the bridge to improve nighttime delineation of the roadway.
- Consider installation of edge lines with 4.0m between edge lines along the bridge in accordance with AS 1742.2:2022 MUTCD Part 2 Figure 4.11.
- Consider providing chevron markings to the shoulder areas on the bridge to clearly show that the bridge is one lane only.

9.2.2	<p>Linemarking</p> <p>The design drawings do not indicate if edge lines are to be painted across the bridge. AS 1742.2:2022 MUTCD Part 2 indicates that edge lines shall be provided for one-way bridges that are greater than 60m in length. The exclusion of linemarking increases the risk of motorists failing to drive in the middle of the bridge, striking the bridge kerbs and motorists thinking it is still a two-way bridge.</p>	<p>Risk Ranking: High</p> <p><i>Risk Ranking Decision Process:</i> <i>Frequency: Unlikely</i> <i>Severity: Serious</i> <i>Risk: High.</i></p>	<p>Suggested Actions</p> <ul style="list-style-type: none"> - Consider the installation of edge lines across the bridge in accordance with AS 1742.2:2022 MUTCD Part 2. - Consider the installation of RRPM’s on linemarking approaching and on the bridge to improve nighttime delineation of the roadway. - Consider installation of edge lines with 4.0m between edge lines along the bridge in accordance with AS 1742.2:2022 MUTCD Part 2 Figure 4.11. - Consider providing chevron markings to the shoulder areas on the bridge to clearly show that the bridge is one lane only. 	<p>WRD / TRS include edge lines in bridge delineation plan. CRC to include chevron and RPPM as necessary in Bridge Approach Design.</p>	<p>This is for consideration bridge design RPEQ. CRC have reinforced the need with the notations for on sheet 6 – for the project signage and linemarking</p>

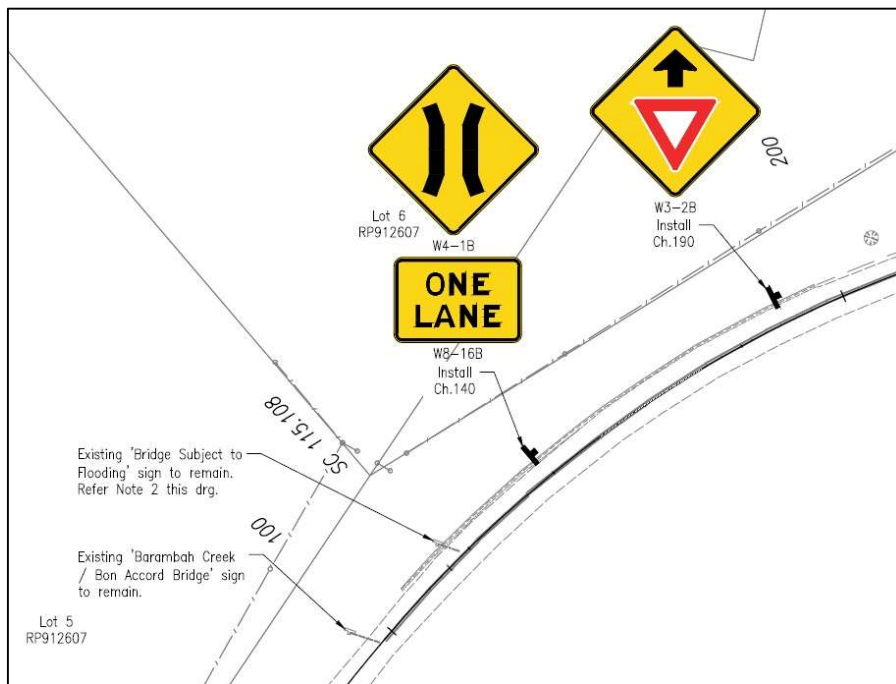
Figure 7: Existing and New Signage

The design drawings show existing signage that is to remain and new signage to be installed on the western approach to the bridge. This signage is insufficiently spaced (refer figure 6 below). The “Give Way Ahead” sign has been positioned at the absolute minimum separation to the give way sign. The approach to the give way is on a 10% down grade and will require greater stopping distance (refer figure 7 below). This increases the risk of motorists being unable to comprehend all signage information and result in overshooting the giveaway and crashing head on with oncoming traffic on the single lane bridge.

Risk Ranking Decision Process: Frequency: Unlikely, Severity: Serious, Risk: High.

- Consider providing sufficient separation between all signage on the approaches to the bridge.
- Consider providing a greater separation between the “Give Way Ahead” and “Give Way” signs to provided sufficient time for motorist to comprehend and react on the 10% decline.

Clause No.	Audit Findings	Risk Level	Audit Recommendations	Project Manager Accept: Yes or No	Design RPEQ Reasons / Comments
9.2.4	<p>Signage Spacing</p> <p>The design drawings show existing signage that is to remain and new signage to be installed on the western approach to the bridge. This signage is insufficiently spaced. The “Give Way Ahead” sign has been positioned at the absolute minimum separation to the give way sign. The approach to the give way is on a 10% down grade and will require greater stopping distance. This increases the risk of motorists being unable to comprehend all signage information and result in overshooting the give way and crashing head on with oncoming traffic on the single lane bridge.</p>	<p><u>Risk Ranking: High</u></p> <p><u>Risk Ranking Decision Process:</u> <i>Frequency: Unlikely</i> <i>Severity: Serious</i> <i>Risk: High.</i></p>	<p>Suggested Actions</p> <ul style="list-style-type: none"> - Consider providing sufficient separation between all signage on the approaches to the bridge. - Consider providing a greater separation between the “Give Way Ahead” and “Give Way” signs to provided sufficient time for motorist to comprehend and react on the 10% decline. 	<p>Comments noted, CRC to amend plans to address suggested actions recommended.</p>	<p>W3-2 signage was positioned at the absolute minimum required distance. If preferred these can be moved further out and the IFC to be updated to reflect this preference.</p>

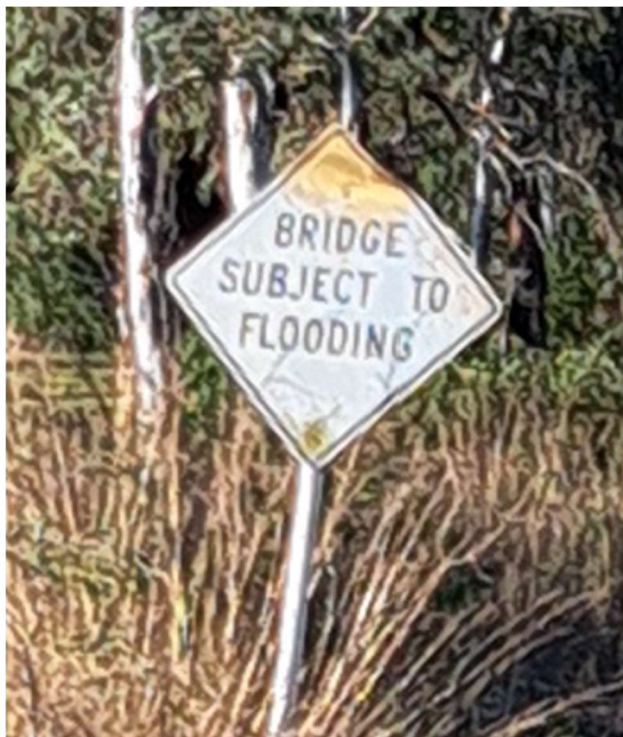
Figure 9: Existing “Bridge Subject to Flooding” Sign

The design drawings indicate that an existing “Bridge Subject to Flooding” warning sign is to remain. The sign referenced is in poor condition (based on Google Street View 2021) and is a non-standard sign, increasing the risk of motorist’s confusion and lack of understanding of the upcoming hazard.

Risk Ranking Decision Process: Frequency: Unlikely, Severity: Moderate, Risk: Medium.

- Consider removing the existing sign that is in poor condition and install current standard road subject to flooding signage inclusive of flood depth indicators in accordance with AS 1742.2:2022 MUTCD Part 2.

9.2.5	<p>Non-Standard/ Poor Condition Signage</p> <p>The design drawings indicate that an existing “Bridge Subject to Flooding” warning sign is to remain. The sign referenced is in poor condition (based on Google Street View 2021) and is a non-standard sign, increasing the risk of motorist’s confusion and lack of understanding of the upcoming hazard.</p>	<p><u>Risk Ranking: Medium</u></p> <p><u>Risk Ranking Decision Process:</u> <i>Frequency: Unlikely</i> <i>Severity: Moderate</i> <i>Risk: Medium.</i></p>	<p>Suggested Actions</p> <ul style="list-style-type: none"> - Consider removing the existing sign that is in poor condition and install current standard road subject to flooding signage inclusive of flood depth indicators in accordance with AS 1742.2:2022 MUTCD Part 2. 	<p>Comments noted, CRC to amend plans to address suggested actions recommended.</p>	<p>Noted on IFC 01/07/2024 for NBRC consideration. IFC to be updated with revised preference to reflect this comment for signage renewal and MUTCD compliance. .</p>

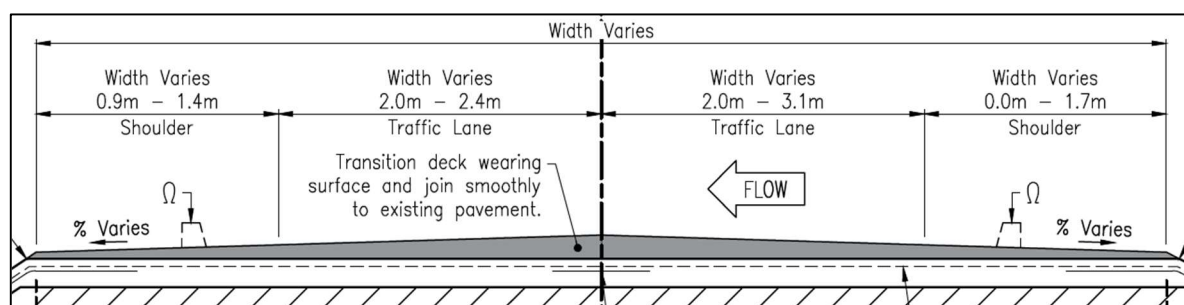
Figure 10: Cross Section with Proposed New Kerbing

The typical cross sections show proposed new kerbing on the approach to the new bridge. The location shown is positioned in the middle of the road shoulder. The proposed location is not detailed anywhere else within the drawing set. If the new kerbing is to be introduced mid shoulder, there is a risk that motorists could strike the end of the kerb increasing the risk of loss of control crashes.

Risk Ranking Decision Process: Frequency: Unlikely, Severity: Serious, Risk: High.

- Consider updating plans to detail full kerb setout.
- Consider introducing kerbing at the edge of the sealed formation and transitioning down to the bridge kerb width.

9.3 Hazards					
9.3.1	Kerb The typical cross sections show proposed new kerbing on the approach to the new bridge. The location shown is positioned in the middle of the road shoulder. The proposed location is not detailed anywhere else within the drawing set. If the new kerbing is to be introduced mid shoulder, there is a risk that motorists could strike the end of the kerb increasing the risk of loss of control crashes.	Risk Ranking: High Risk Ranking Decision Process: <i>Frequency: Unlikely</i> <i>Severity: Serious</i> <i>Risk: High.</i>	Suggested Actions - Consider updating plans to detail full kerb setout. - Consider introducing kerbing at the edge of the sealed formation and transitioning down to the bridge kerb width.	Comments noted, CRC to amend plans to address suggested actions recommended.	To be included in an updated IFC drawings due to bridge positioning of bridge detailed design IFC altering.

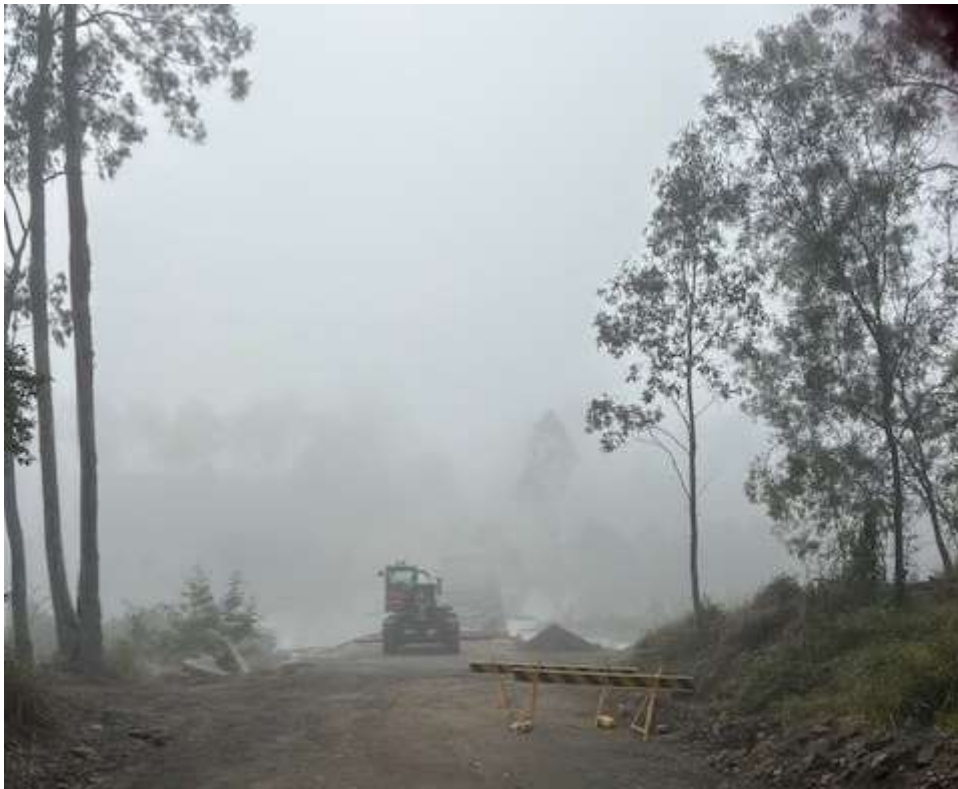
Figure 11: Fog along Bon Accord bridge

It was brought to the auditor’s attention that the Bon Accord bridge site experiences fogs at times impacting on motorists’ visibility. The lower visibility conditions could result in poor decision making by motorists entering onto the one lane bridge especially if motorists do not have their headlights on.

Risk Ranking Decision Process: Frequency: Unlikely, Severity: Serious, Risk: High.

- Consider the need to install Warning Sign “Heavy Fog Headlights on for Safety” TC1733 on the approaches to the bridge.

9.3.2	Bad Weather It was brought to the auditor’s attention that the Bon Accord bridge site experiences fogs at times impacting on motorists’ visibility. The lower visibility conditions could result in poor decision making by motorists entering onto the one lane bridge especially if motorists do not have their headlights on.	Risk Ranking: High Risk Ranking Decision Process: <i>Frequency: Unlikely</i> <i>Severity: Serious</i> <i>Risk: High</i>	Suggested Actions - Consider the need to install Warning Sign “Heavy Fog Headlights on for Safety” TC1733 on the approaches to the bridge.

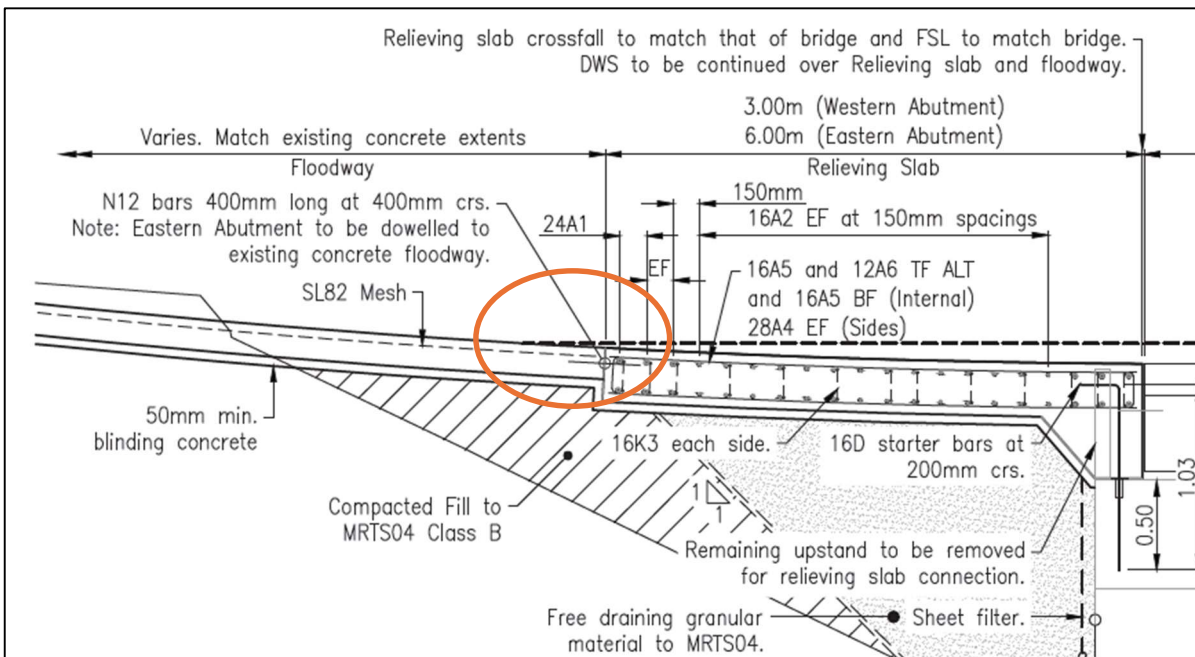
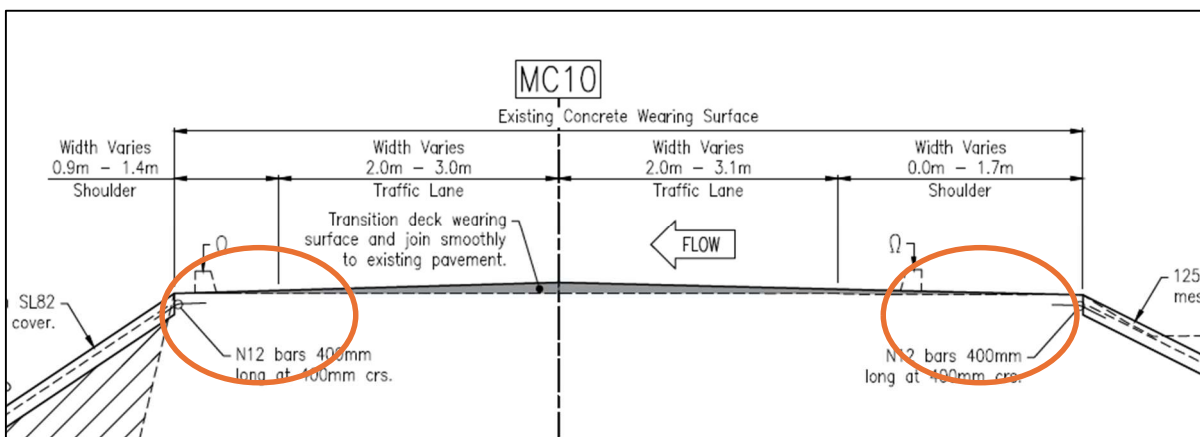
Figure 12: Feathering of Deck Wearing Surface

The design proposes to transition and feather out the new bridge deck wearing surface to the approach concrete slabs. Deck wearing surfaces need to be laid to a minimum thickness and cannot be feathered out to a zero thickness. If placed as shown within the design drawings, there is a risk that the wearing surface could delaminate from the concrete approaches during flood events resulting in a rough road surface, increasing the risk of loss of control crashes.

Risk Ranking Decision Process: Frequency: Unlikely, Severity: Serious, Risk: High.

- Consider keying the deck wearing surface into the concrete approaches, or
- Consider amending the road grading on the approaches to the concrete slabs to allow for a minimum thickness wearing surface layer to be applied over the concrete approaches to the bridge, or
- Consider constructing the approach concrete slabs flush to the new bridge relieving slab profile with minimum depth deck wearing surface.

9.4 Constructability					
9.4.1	Deck Wearing Surface The design proposes to transition and feather out the new bridge deck wearing surface to the approach concrete slabs. Deck wearing surfaces need to be laid to a minimum thickness and cannot be feathered out to a zero thickness. If placed as shown within the design	Risk Ranking: High Risk Ranking Decision Process: <i>Frequency: Unlikely</i> <i>Severity: Serious</i> <i>Risk: High.</i>	Suggested Actions - Consider keying the deck wearing surface into the concrete approaches, or - Consider amending the road grading on the approaches to the concrete slabs to allow for a	Comments noted, CRC to amend plans to address suggested actions recommended. Note; the approaches to match bridge DWS levels, therefore avoiding feathering of AC.	Preference was for the new approach and relieving slab to match to DWS, but construction sequencing proposed at the time (bridge in after) restricts ability to match well. It is understood that

Clause No.	Audit Findings	Risk Level	Audit Recommendations	Project Manager Accept: Yes or No	Design RPEQ Reasons / Comments
	drawings, there is a risk that the wearing surface could delaminate from the concrete approaches during flood events resulting in a rough road surface, increasing the risk of loss of control crashes.		minimum thickness wearing surface layer to be applied over the concrete approaches to the bridge, or - Consider constructing the approach concrete slabs flush to the new bridge relieving slab profile with minimum depth deck wearing surface.		there has since been further modification to the bridge positioning due to the existing abutment ledge height and now concrete relieving slab can match DWS. IFC to be updated to reflect

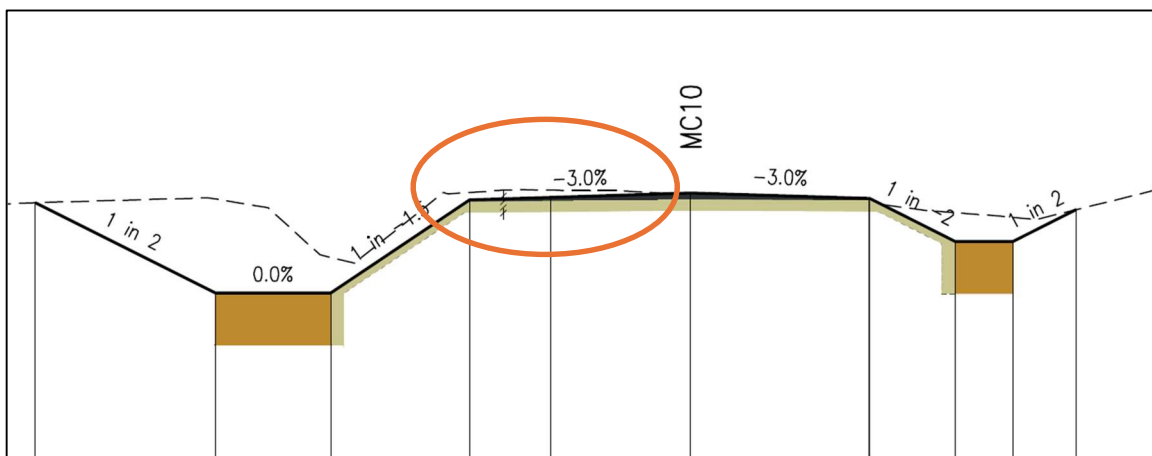
Figure 14: Cross Section at Start of Project

The design cross sections show that the new design profile does not match the existing road shape at the start of the project. If the new construction matches the design plans there will be a rough connection to the existing roadway at the start of the project that increases the risk of loss of control crashes.

Risk Ranking Decision Process: Frequency: Unlikely, Severity: Serious, Risk: High.

- Ensure that smooth connections are provided between existing and new work.
- Ensure that design standards are adhered to for rotations of road crossfall to match at tie in locations.

9.4.2	Cross Section Profile at Start of Project The design cross sections show that the new design profile does not match the existing road shape at the start of the project. If the new construction matches the design plans there will be a rough connection to the existing roadway at the start of the project that increases the risk of loss of control crashes.	<u>Risk Ranking: High</u> <i>Risk Ranking Decision Process:</i> <i>Frequency: Unlikely</i> <i>Severity: Serious</i> <i>Risk: High.</i>	Suggested Actions - Ensure that smooth connections are provided between existing and new work. - Ensure that design standards are adhered to for rotations of road crossfall to match at tie in locations.	Comments noted, CRC to amend plans to address suggested actions recommended.	To be amended in revised IFC
