North Burnett Regional Council

# DRINKING WATER QUALITY MANAGEMENT PLAN

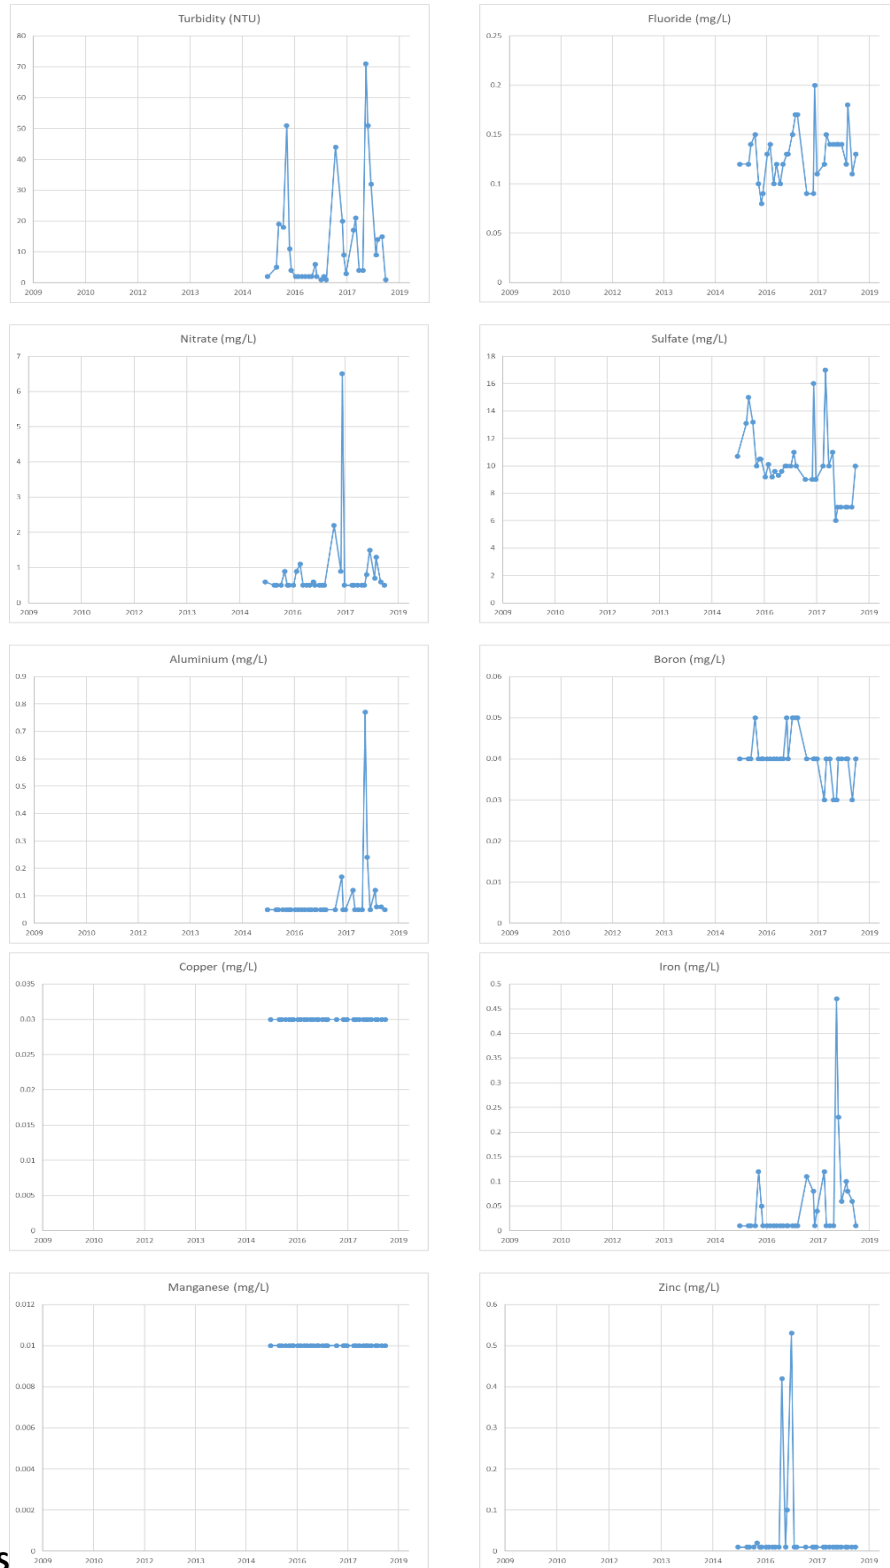
### Mingo Crossing – Raw Water 2016 – 2018

The results are spread across the twelve-month period of the year indicated. Note the orange lines indicate the ADWG limits.

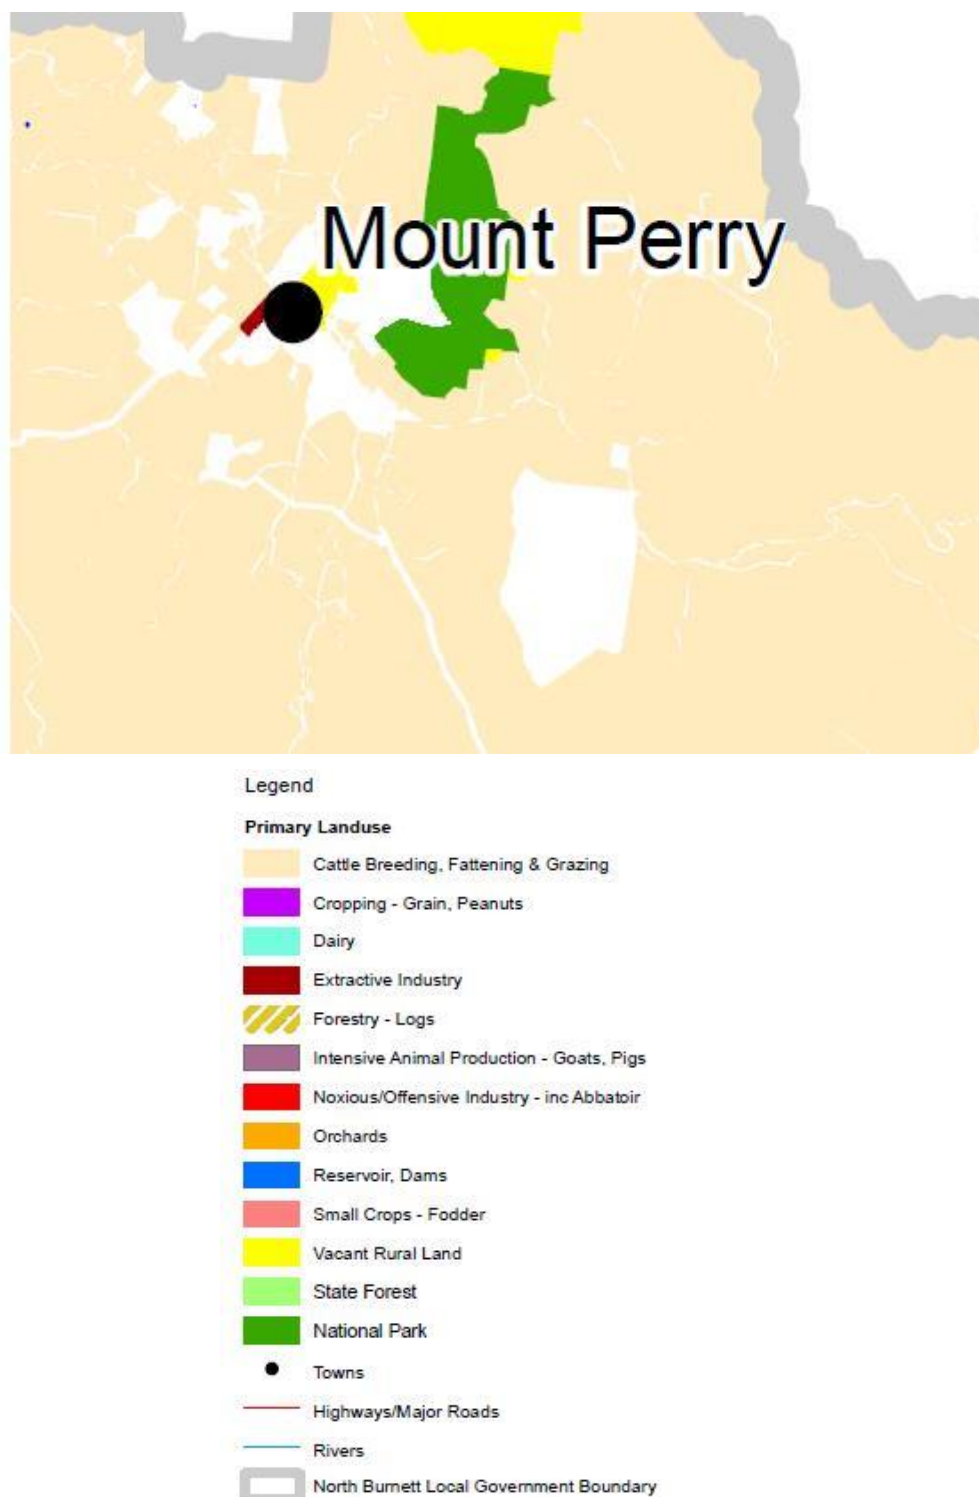
**Figure 9-3 Mount Perry Catchment Area**

The general terrain around the township of Mount Perry is hilly to mountainous. Most of the district is unimproved grazing land. Gold mining occurs on the south eastern outskirts of Town. Influence of this activity on the town water source is non-detectable. The bores are fully enclosed, housed and inside a locked perimeter fence. There are no known potential influences that would affect the water quality.

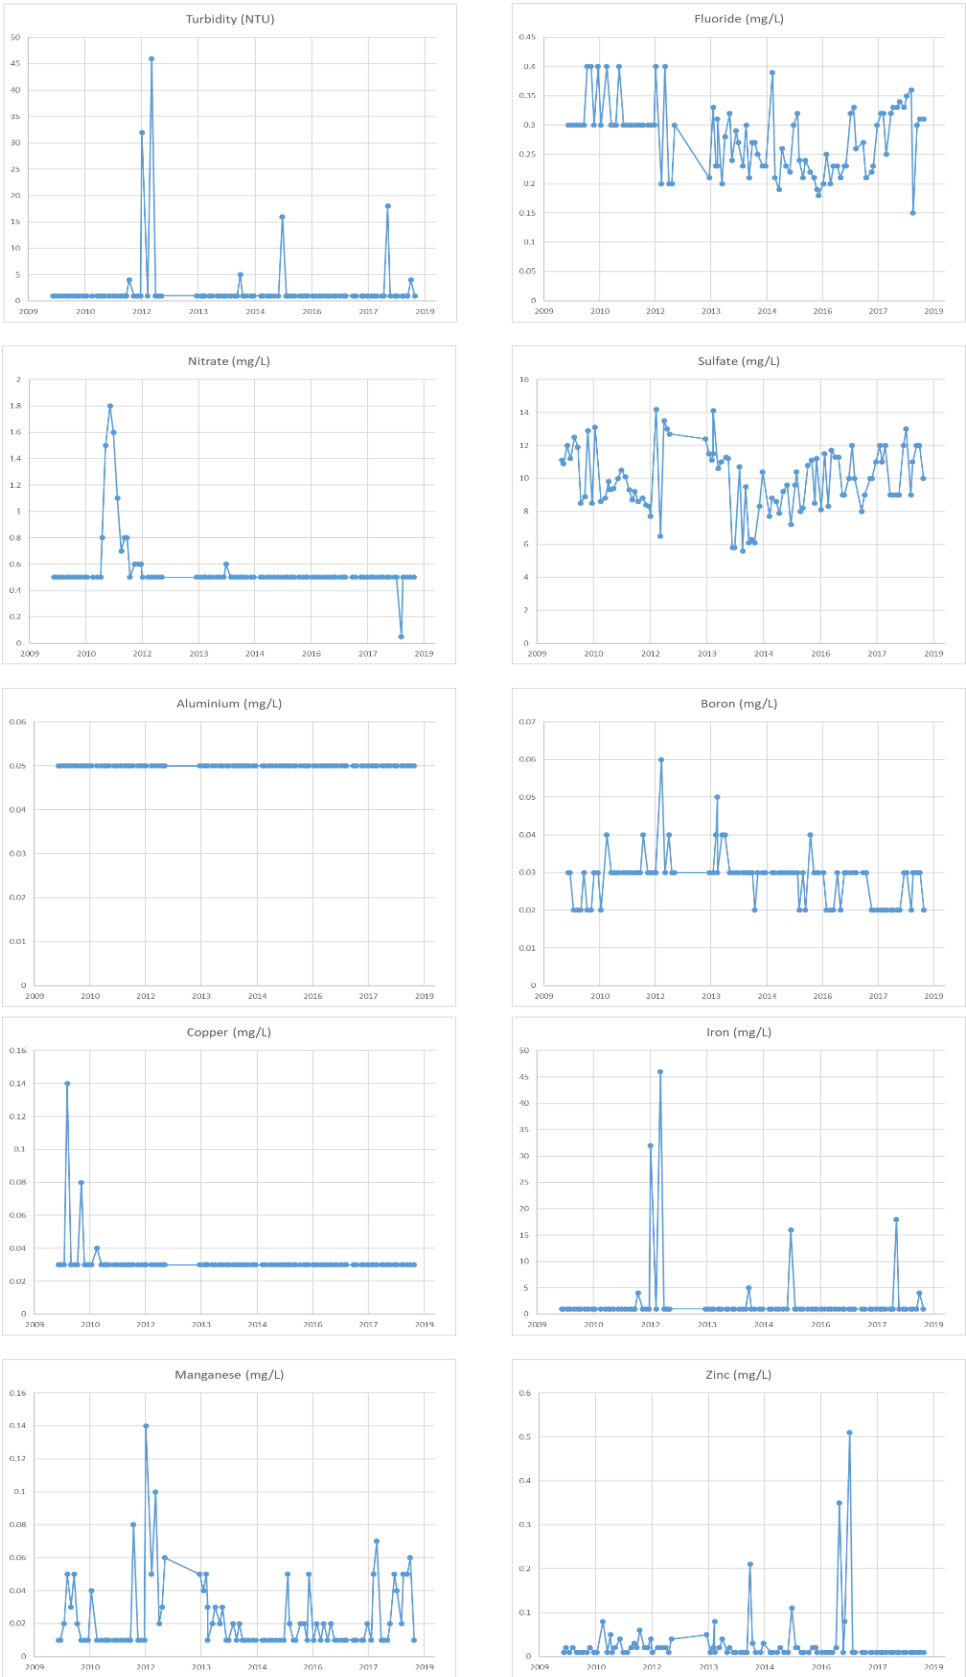
# Mount Perry untreated bore water 2010-2018

The results are spread across the twelve-month period of the year indicated. Note the orange lines indicate the ADWG limits.
